Analysis of the Root Causes of Transformer Bushing Failures

E. A. Feilat, I. A. Metwally, S. Al-Matri, and A. S. Al-Abri

International Science Index, Electrical and Computer Engineering Vol:7, No:6, 2013 waset.org/Publication/4707

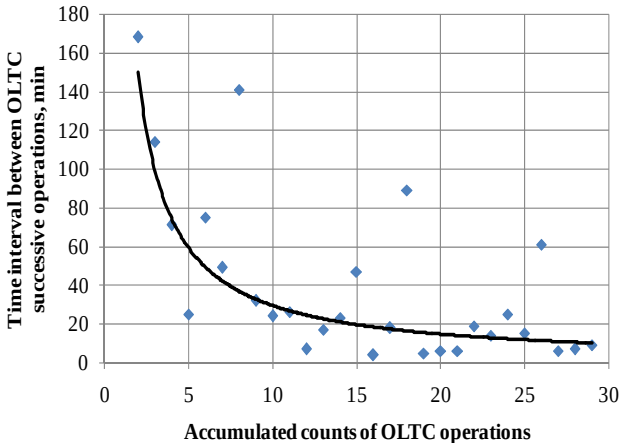
Fig. 3 JBB Grid station, TX1, 8-9-2011

Statistical analysis of the faulty operation of the OLTCs of JBB Ali Grid S/S is depicted in Fig. 3. Fig. 3 shows the time

interval between OLTC successive operations for the faulty JBB Ali Grid transformer. The results indicate that the OLTC time intervals are too small which implies an abnormal operation as a result of frequent variation of the 33 kV voltage level of the 125 MVA transformers. This fast variation could be attributed to successive partial discharges activities in the bushing insulation.

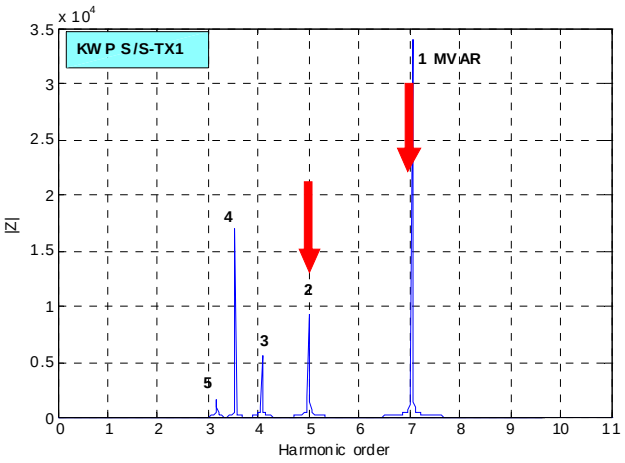
Fig. 4 Impedance scan- Al Kamel water pump S/S (TX1)

11 kV-bus where the capacitor banks are located has been computed for the ten S/Ss. Fig. 4 displays the frequency scan for Al Kamel water pump S/S. The results indicate that there is a possibility of resonance at the 5th and 7th harmonic frequencies. Therefore, if either the 5th or 7th harmonic current exists, the corresponding magnified harmonic voltage will be superimposed on the 50-Hz 11-kV bus.

Examining Fig. 4, it can be seen that harmonic parallel resonance at Al Kamel water pump S/S-TX1 is possible at the 5th and 7th harmonic frequencies corresponding to 3 and 1 MVAR compensation, respectively. The overall impedances of the combination of the capacitor bank and system equivalent short-circuit reactance as seen from the PCC Z_{R5}= 90 kΩ Z_{R7}= 34 kΩ, respectively. For 5th and 7th harmonic currents I_{h5} =2.3% and I_{h7} =0.7%, with I_{h1}=24 A, the corresponding magnitudes of the magnified 5th and 7th harmonic voltages are V_{h5} =75% and V_{h7} =86%, respectively. However, the damping provided by resistance in the system and the overvoltage surge arresters are often sufficient to prevent catastrophic voltages and currents.

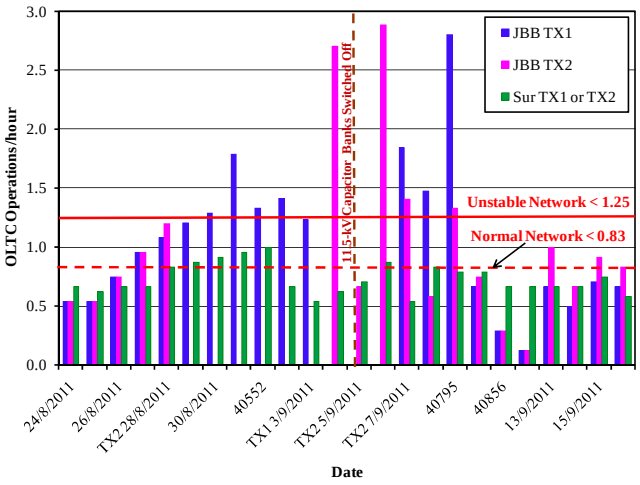
Fig. 5 Hourly-operations 132-kV OLTC at JBBA and Sur Grid S/Ss

The frequency of operations of the OLTCs of TX1 and TX2 of the 132/33 kV 125 MVA transformers at JBB Ali Grid S/S is compared to that of the healthy Sur Grid S/S during the time interval from 24/08/2011 to 16/09/2011 as depicted in Fig. 5. It can be seen that the OLTC of either Sur transformers (TX1 or TX2) hourly operation (i.e. number of tap changers operations per hour) are within the normal network operations i.e. 20 operations per day or <0.83 operations/hour [9]. On the other hand, the OLTC of either TX1 or TX2 at JBB Ali Grid S/S exhibits abnormal hourly operations i.e. above the normal network. This abnormal operation appeared on 27/08/2011 and 28/08/2011, which resulted in failure of TX2 on 28/08/2011 and TX1 on 03/09/2011, respectively.

Likewise, another severe abnormal operation that exceeds the unstable network i.e. 30 operations/day or >1.25 operation/hour was observed on 04/09/2011. As a result, TX2 failed on 05/09/2011. These abnormal operations continued and yielded to two failures of TX2 on 07/09/2011 and TX1 on 08/09/2011, respectively even after switching off the capacitor banks at the 11.5 kV bus of MZEC JBB Ali 33/11.5 kV S/S.

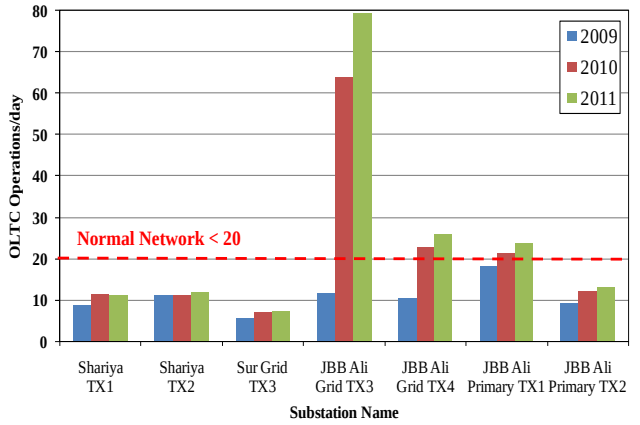
Fig. 6 Average daily operations of 33-kV OLTC in 2009, 2010 and 2011

For the sake of comparison, Fig. 6 shows the frequency of transformer OLTC operations at different 33/11.5 kV MZEC S/Ss including Sur Grid, JBB Ali Grid, JBB Ali primary and Shariya S/S in 2009, 2010 and 2011. It can be seen that TX3 transformer at JBB Ali Grid S/S exhibiting abnormal operation since 2010, where the number of daily operations

exceeds 20indicating unstable network operations at the JBB Ali Grid S/S.

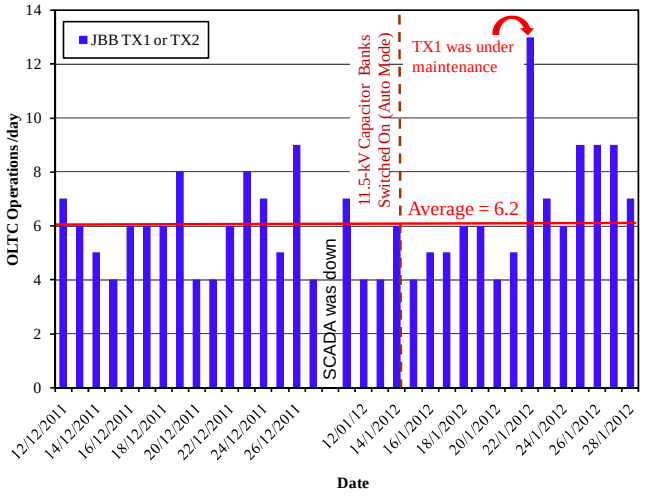
Fig. 7 Hourly 132-kV OLTC at JBB Grid S/S in Dec. 2011 and Jan. 2012 before and after switching-on of the 11.5-kV capacitor banks

This average number of operations was within the known operation range for normal networks [9] even after switching on the 11 kV capacitor banks at JBB Ali grid S/S to the auto mode. No significant effect of switching on the capacitor banks on OLTC operations per day in Dec. 2011 and Jan. 2012.

Following the five failures of TX1 and TX2, the six 33 kV bushings were replaced. Accordingly, the daily operations of the OLTCs of both TX1 and TX2 during the time interval from 12/12/2011 to 28/01/2012 fall within the stable network operation as demonstrated in Fig. 7. The average daily operations was 6.2 operations/day or 0.26/hour.
