THE EFFECTS OF A COLUMN DAMAGE TO STRUCTURAL BEHAVIOR OF A LOW-STRENGTH CONCRETE BUILDING

Atakan MANGIR*, Turgay ÇOŞGUN, Barış GÜNEŞ

Istanbul University, Faculty of Engineering, Department of Civil Engineering, Istanbul, Turkey

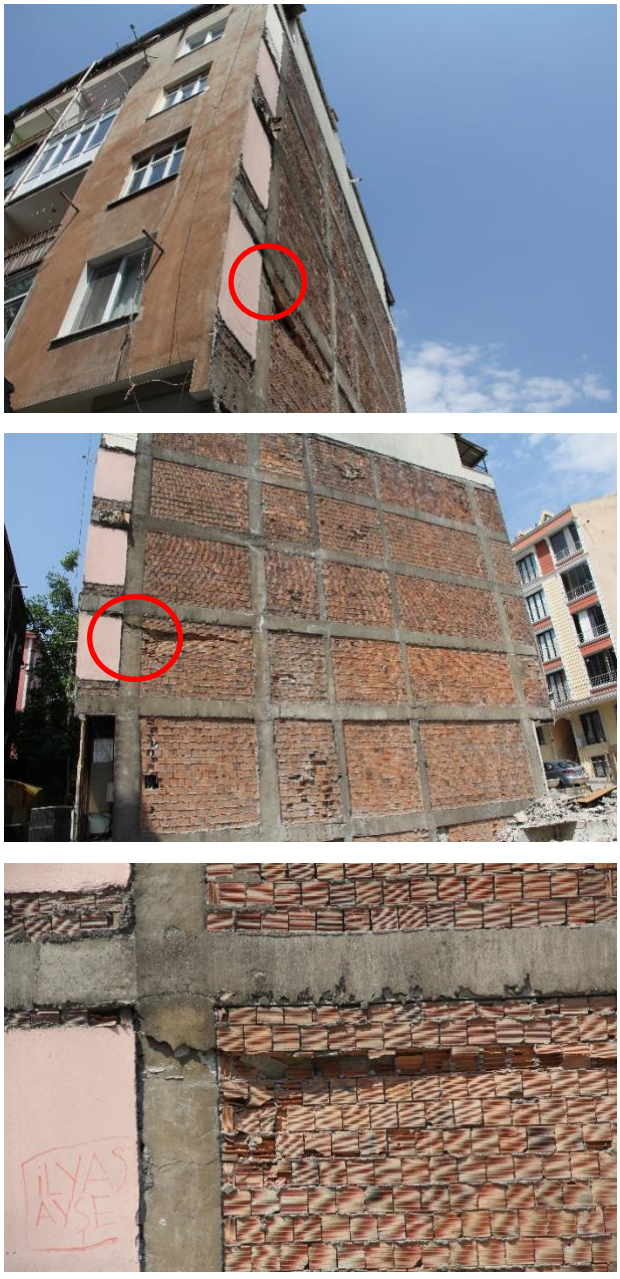
Figure 3. The damaged column (1/2)

A column located at the periphery of the 4th story has been damaged with a hit of a construction equipment during the demolition process in the next parcel. The exact location and the damage on the related column are shown in Figures 3 and 4.

The column is heavily damaged from a point near the top joint. It can be seen also in the next figures that the crack width is measured up to 5 cm. Some of the longitudinal reinforcements in the column are buckled and some of them are ruptured. It should be noted that, when the incident occurred, a part of the column was shifted from its vertical axis resulting in an undesired eccentricity. Thus, this situation should be considered while determining an appropriate strengthening method.

Two different strengthening approaches may be followed for this region. As the first option, the crack can be filled with high-strength cement-based materials. As the second option, the column can be re-constructed keeping the unbuckled part of longitudinal reinforcements and total destruction of the damaged column. Thus, new bars will be attached to existing bars and concrete can be filled around. Since most of the existing reinforcements are ruptured in the related area, the second option will be preferable.

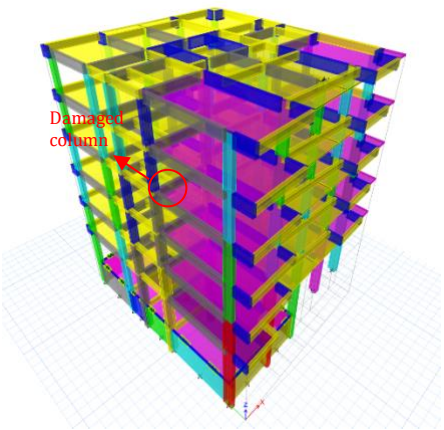
Figure 5. 3D View of the analysis model

Three-dimensional analyses were conducted using the structural analysis software ETABS (CSI, 2016) for nonlinear analysis of the structure. The effective stiffness for beams is assumed as 0.4EI (flexural rigidity of the cross-section) according to TSC (2007). Live load acting on the structure is defined as 2.0 kN/m^2 and floor coating load is defined as 1.5 kN/m^2. The partition wall loads are applied as line loads on related beams (3.2 kN/m^2 x story height at the periphery and 2.5 kN/m^2 x story height at the interior). Live load participation factor for residential buildings is defined as "0.3" in TSC (2007). The building information level is assumed as "Medium Information Level" defined in TSC (2007). Thus, 90% of the actual material strength values are used in the analyses. Beam, column and squat-wall elements are modeled as nonlinear frame elements with lumped plasticity by defining plastic hinges at both ends of the members (Kazaz et al., 2012). Fiber hinges are used in vertical structural members. Analysis model is shown in Figure 5.

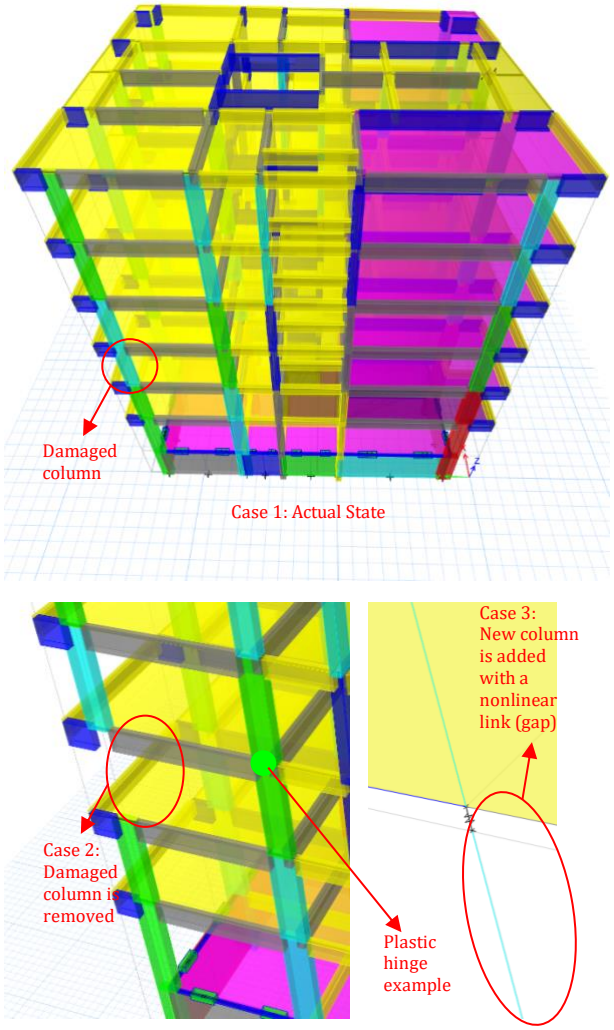
Figure 6. Representation of 3 different models (1st actual, 2nd damaged, 3rd strengthened)

Incremental single mode pushover scenarios start with vertical pushover with full loading. Then, lateral pushover steps are continued up to the target displacement values assuming vertical pushover results as initial conditions. Three different cases are created to simulate the undamaged, damaged and strengthened states. Nonlinear analysis is carried in three dimensions (PushG, PushX, PushY) to capture the behavior of the structure. In the first case, the undamaged state of the structure is analyzed. In the second case, the damaged column is removed and analyses are repeated. In the third case, a new column is attached instead of the damaged one. The vertical displacement obtained from the second model at the joint supported by damaged column is applied to the third case by defining a nonlinear link (gap) element connecting the top joint and new column's top end. By this manner, the columnless case's vertical displacement until the start of lateral pushover step is taken into consideration. This technique provides a better approach to consider the vertical displacement occurred during the absence of column support. The attached column has moment releases at both ends. Figure 6 shows the details of three cases.

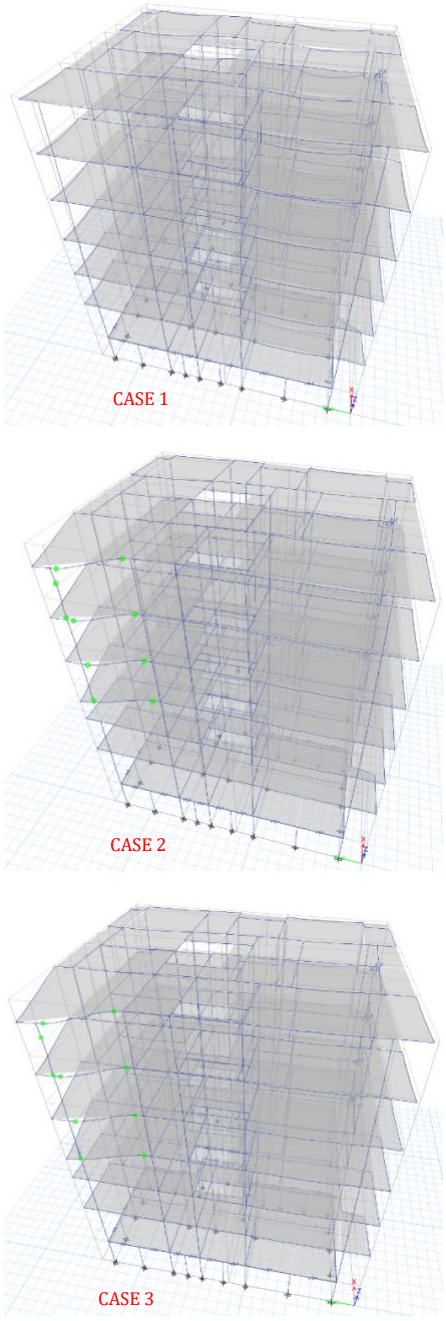
Figure 7. Plastic Hinge formation at the end of vertical pushover (Push-G) analysis

In the first case, no plastic hinge formation observed since the region was not damaged. In Case 2, the vertical deformation of the top joint is calculated as 21 mm. The vertical movement of the damaged region caused the formation of plastic hinges on the members located above the damaged zone. Since the first case's vertical deformation freedom on the damaged region's top joint is assigned to case 3 with a nonlinear gap element, similar plastic hinge formation is observed in the case 3. It should be noted that, in the case where the damaged zone is represented by a deleted column, the damaged region affected most of the beams connecting the columns on the upper floors. The plastic hinge formation on damaged members shows that, yield moment capacity of the members is exceeded and irreversible plastic deformations are occurred. The lateral pushover cases' hinge formations for both directions are given in Figure 8.

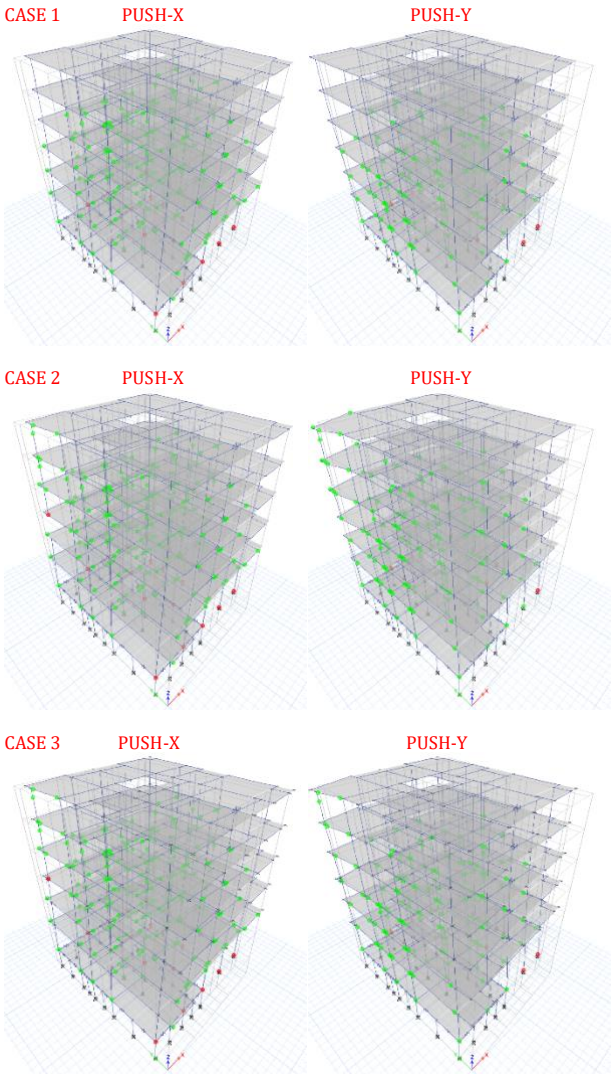
Figure 8. Plastic Hinge formation at the end of lateral (Push-X and Push-Y) pushover analysis

Deformed shapes at the end of lateral pushover analysis of all cases show that some columns located on the base floors exceeded their ultimate strain limit (red marked ones). Some beams and columns are also exceeded their yield strain limit (green marked ones). The upper column located above the damaged zone reached its ultimate strain capacity in X direction's pushover analysis (Case2&3). This is because of previously occurred plastic deformations at the end of vertical pushover analysis. Most of the structural members located above the damaged region have irreversible plastic deformations in cases 2 and 3. Same members do not have such deformations in case 1. The results of an example plastic hinge on a beam connected to the damaged region (marked with a green circle in Figure 6) is shown in Figure 9 in order to compare the aforementioned effects. The pushover curves of both cases are given in Figure 10.

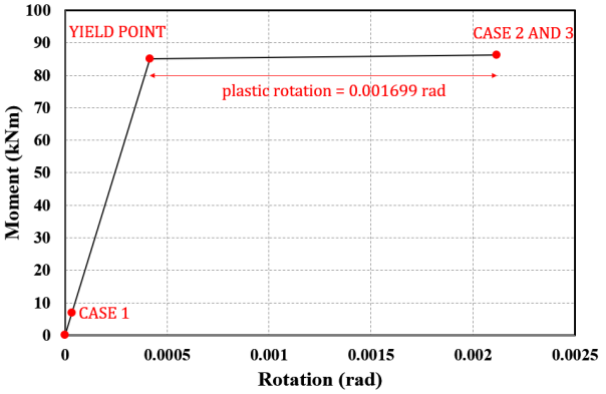
Figure 9. Moment-rotation results of an example plastic hinge at the end of the vertical pushover analysis (Push-G)

At the end of vertical pushover analysis (Push-G), the example beam exceeded its yield moment capacity

(around 85kNm) and plastic rotations are formed as 0.001699 rad in cases 2 and 3. However, when the same beams' plastic hinge state is considered for the undamaged case, the moment on the section is far below than the yield moment value (around 6.89 kNm) and there is not any plastic rotation occurred. In other words, for the undamaged model (case 1), the hinge states of the structural elements in the related region have remained in the elastic zone.

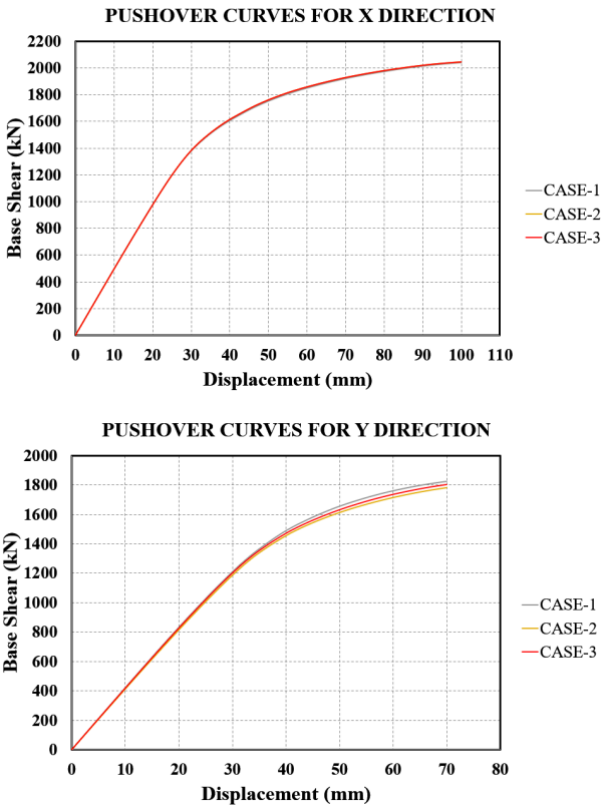
Figure 10. Pushover curves

It is understood from the pushover curves that in X direction, all of three cases have given nearly same results. However, case 1 has higher performance than case 3 which is also higher than case 2 in Y direction. The higher performance of case 3 than case 2 shows the effect of strengthening on the overall seismic performance of the building. When the base shear values are compared, the difference between three cases' results in Y direction is around 1.3%. Since the trend of the three curves is nearly similar, this value may not be considered as a significant difference. The maximum base shear for three cases are found around 2040 kN in X direction and 1840 kN in Y direction. The building's overall performance is not enough to reach the target displacement value. It can be said that the local damaged column does not have a significant role in the seismic performance of the building with respect to these results.
